# The Right Tools to Improve Tablet Production

*In this case study, a variety of challenges encountered when producing a stimulant laxative in the form of a 5mm round tablet are addressed.*

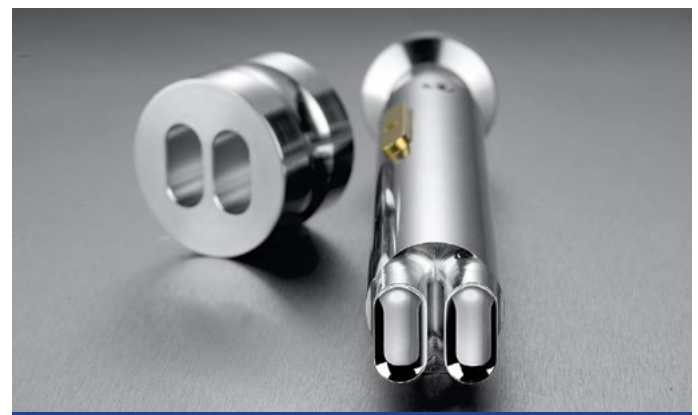
**FIGURE 1:** Monoblock multi-tip tooling helps to increase productivity

Due to the proactive approach taken by the tablet compression specialists at Novartis and an excellent working partnership with I Holland's technical support staff and local agent Vis Viva, tooling was integrated which incorporated the coating solutions and the superior monoblock multi-tip; this resulted in much improved productivity.

The new monoblock multi-tip, with the suggested coating, helped to reduce the overall cost, increase productivity and ensure the consistency of the punch length.

With the combination of well manufactured multi tip tooling, using the correct raw material and coatings, the use of multi tips help to see greater productivity, and a reduction in run-time per output of tablets, leading to less maintenance per batch and reduced press set-up time.

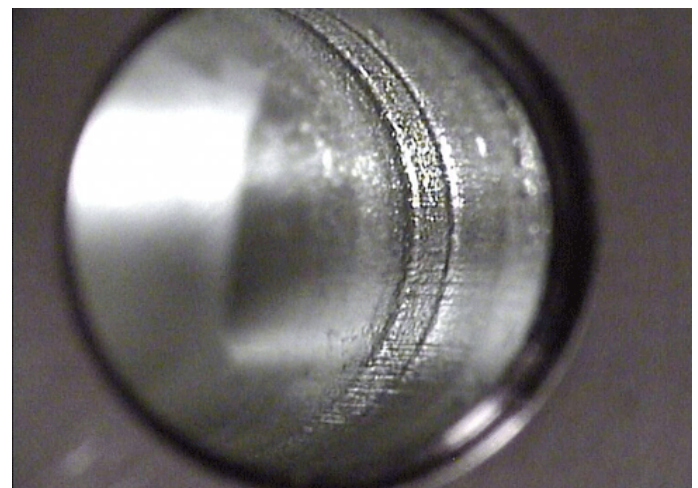
Novartis Italy's tooling from their existing supplier, was seen to wear very quickly with an average of 300 million tablets produced per tooling set and dies having to be turned after just 150 million tablets.

**FIGURE 2:** Excessive wear to the tooling

In addition to the above measures, I Holland's R&D department conducted an in-depth steel analysis. This concentrated on the tool steel and coating being used by the existing supplier to see why it was failing. Trials took place using a variety of coating solutions to observe the effect on the end-product. I Holland advised the use of its premium ESR grade steel with PharmaCote CN+ (Chromium Nitride Plus) and HPG-TC (Tungsten Carbide) dies.

PharmaCote CN+ has impressive anti-stick properties combined with excellent wear and corrosion resistance. It was found to be the best coating solution to combat the challenges being encountered. Together with HPG-TC dies, a material with extremely high wear resistance and compressive strength, the results were outstanding.

The application of the improved use of coating PharmaCote CN+ was trialed and the wear on the tooling was much reduced, this was after increasing compression by 20%. Results also saw no breakage during production. The increased tooling life saw output increase from 300,000 tablets to 400,000 tablets per set.

Use of PharmaCote HPG-TC saw a three-fold reduction on die wear. By changing to the recommended improvements, I Holland helped to increase the working life of the dies by three times, producing one billion tablets.

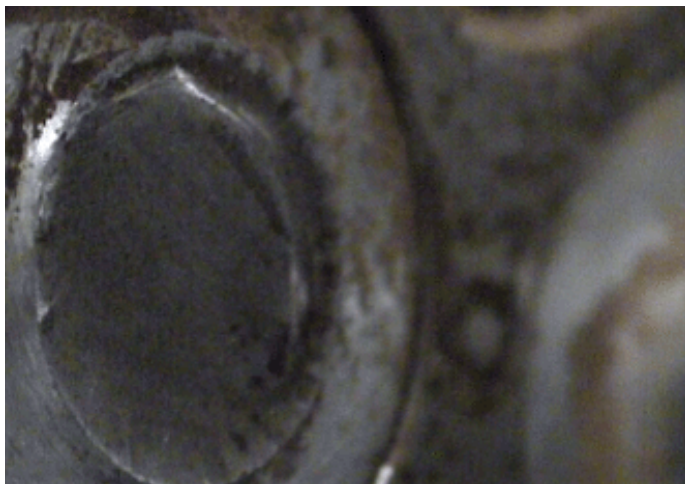
Breakage was another major issue during production. With a maximum force of just 15–17 KN, breakage was still occurring. The lower tip was fracturing regularly, with lateral forces and excessive clearance contributing to the problem.

FIGURE 3: Lower tips were breaking easily

Alongside the change to the dies and the coating used, modifications were made to the clearance and radius on the lower tips. With these adjustments the problems previously encountered were solved completely.

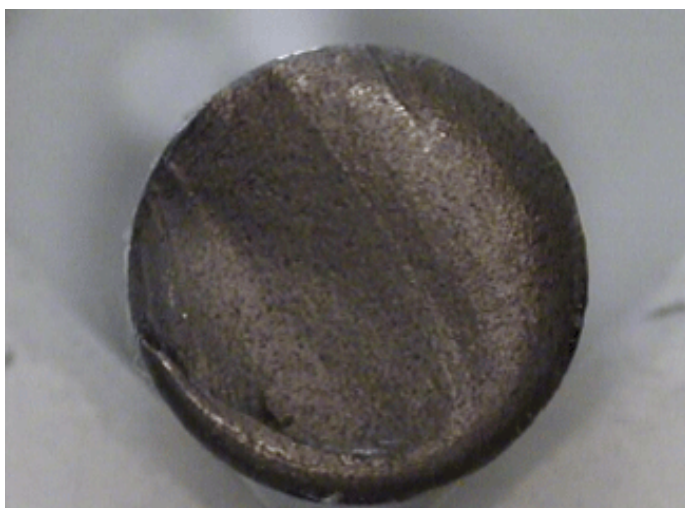
FIGURE 4: Tip breakage

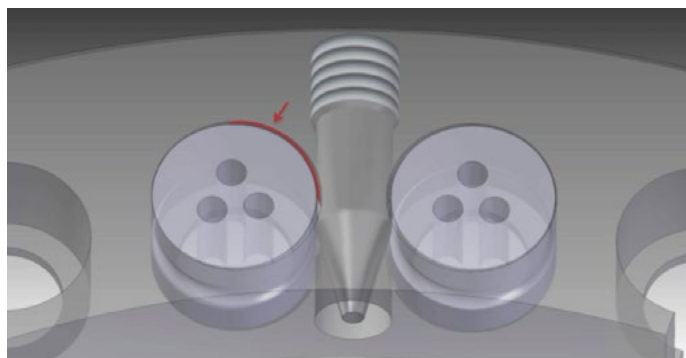
It was found that some of the long-standing presses being used had wear on the turret guides and die bores. This is a challenge that many manufacturers face. These presses had many years of working life to come, but the problem needed a creative engineering solution.

FIGURE 5: Alignment issues were found on the press, with wear of the die pockets

With this in mind, I Holland made new proposals on the die's outer diameter. Due to the wear in the die pockets, an increase in the outer diameter was used to improve the fit, together with an increase in the upper die clearance to allow inter-changeability with the guides being used.

With a monoblock multi tip tool chosen as the best solution to help increase productivity, it was important to use a die alignment tool to check the wear of the die pockets and the alignment of the turret.

If setting of the die is not performed correctly, then both the upper and lower punch can be misaligned when entering the guide causing punch tightness. This will result in contact between punch tips and the die wall causing friction and heating resulting in premature wear.

The size of the die pockets is also important. Dependent on condition, the die table may have to be replaced, or a revised tolerance to the die specification would need to be applied. Die pockets must also be clear of any foreign objects or burrs and the die fixing bullets should be in good condition to ensure the multi tips work to their full capacity.
